Manhole Inspection Summary

Manhole # S33EE1007MH

Insp Date: **3/6/07 2:02 PM**

Location Address: **3805 39TH ST**

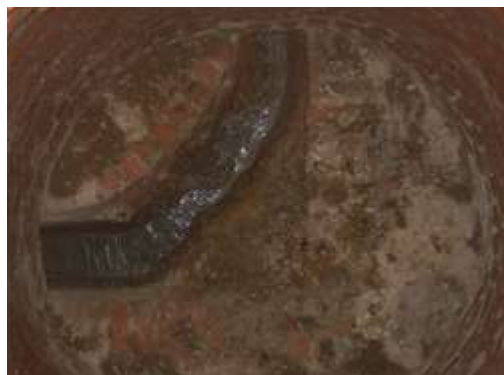
Top View

Bench ☒ Exists Material: **Brick** ☐ Parged ☒ **Debris** (not Condition related)
Condition: ☒ Sound ☐ Cracked ☐ Root Intrusion ☐ Deteriorated ☐ Leaks ☐ Debris

Bench debris

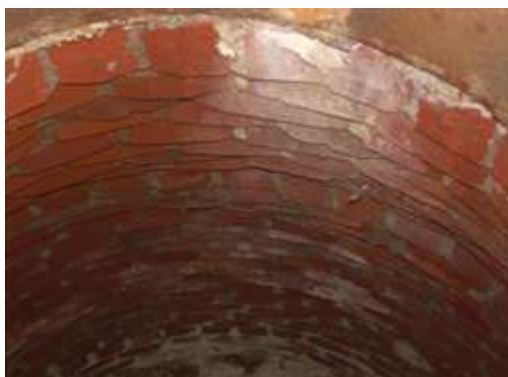
Defect

Frame Offset: **0** (in.) Condition: ☐ Sound ☐ Cracked ☒ **Leaks**

Frame leak

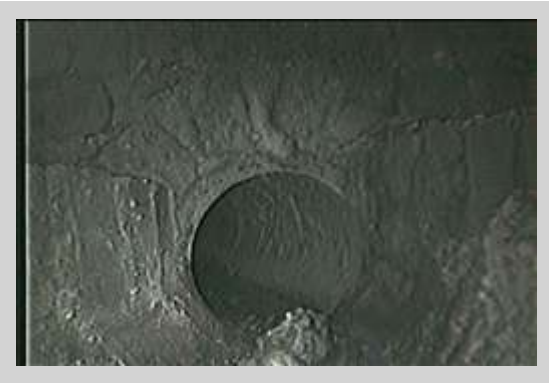
8 in. Circular Gravity Sewer Pipe Out @ 12 O'Clock

Deposits: ☐ None ☒ **Mud** ☐ Sludge ☒ **Debris** ☐ Grease

Silt Depth: **0** (in.) Deposits Extent: **Light**

Infiltration: **None** Pipe Seal Cond: **Cracked**

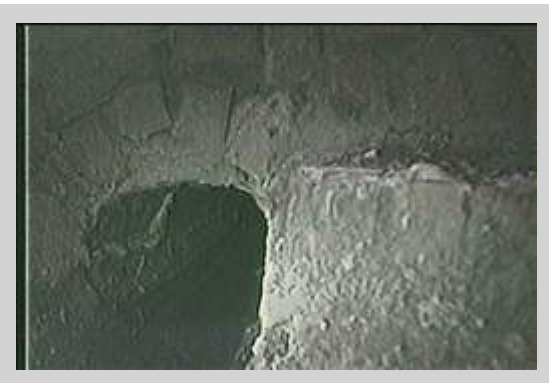
8 in. Circular Gravity Sewer Pipe In @ 9 O'Clock

Infiltration: **None** Pipe Seal Cond: **Cracked**
